# STEVENS-KAHN HOUSE DENVER, COLORADO

Updating a 1901 Victorian brick house to modern insulation standards

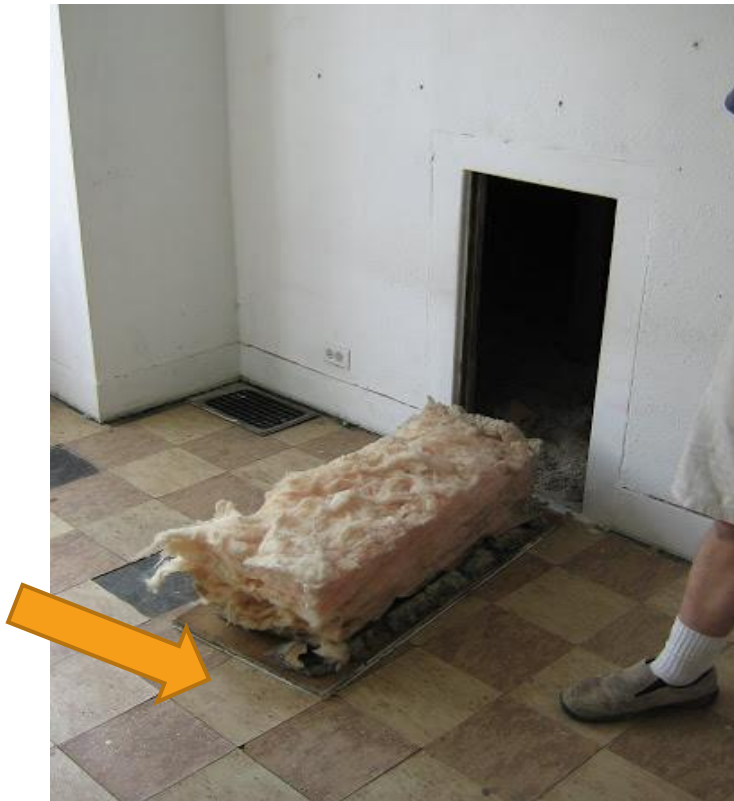
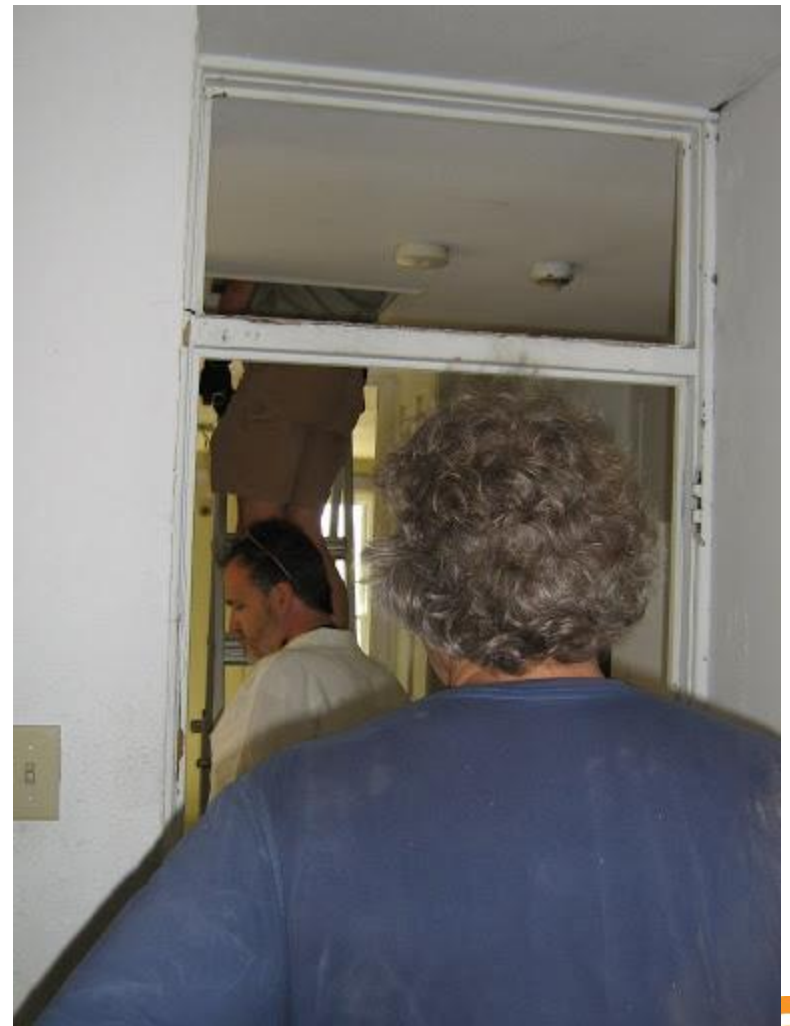
Asbestos tiles on the floor

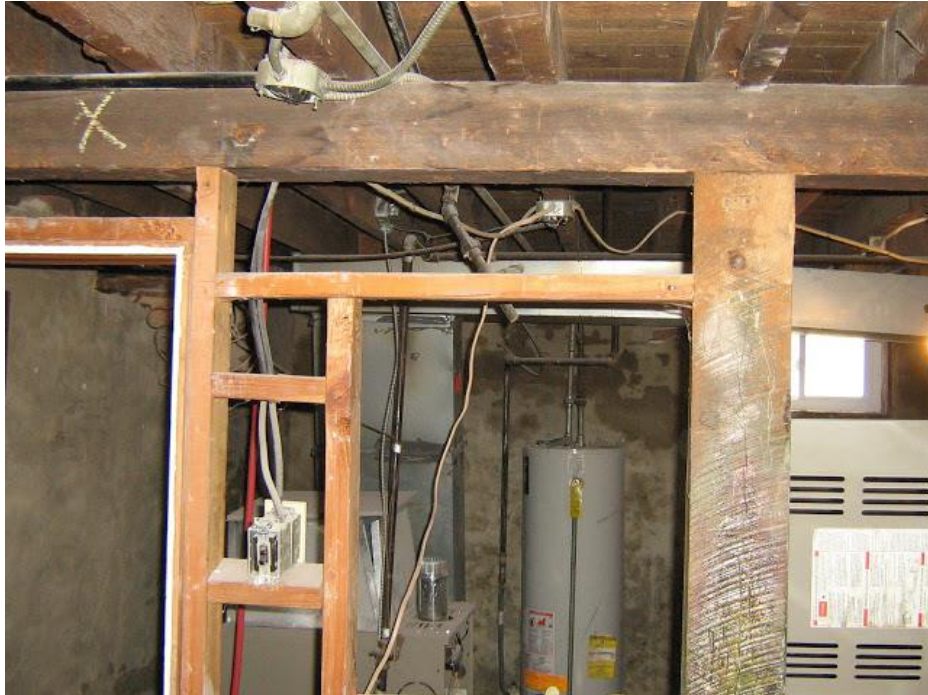
**Basement mechanical room with 80% Goodman Furnace and basic water heater, both now cut in half for display in our training center.**

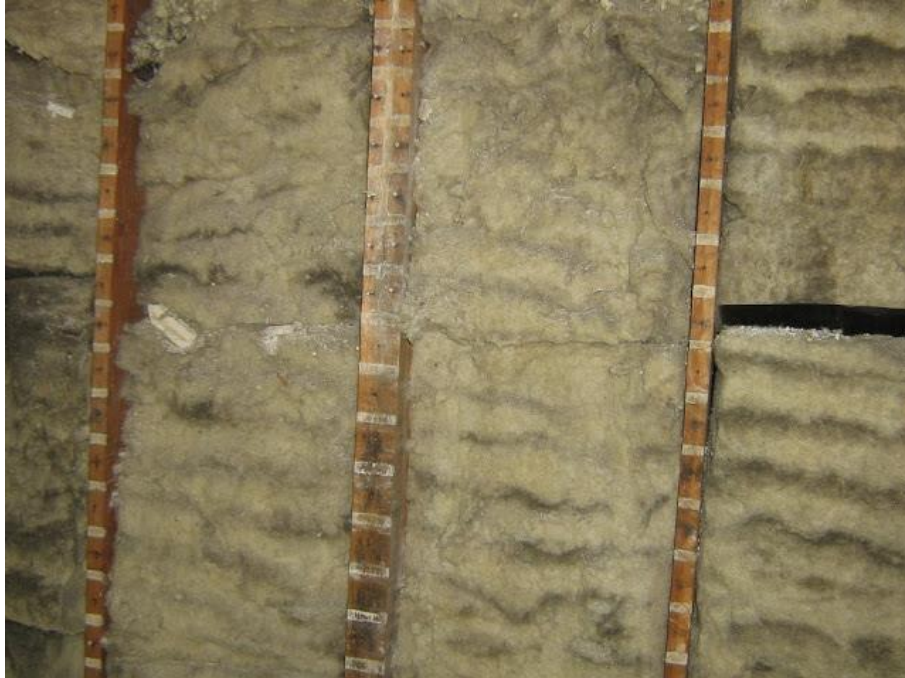
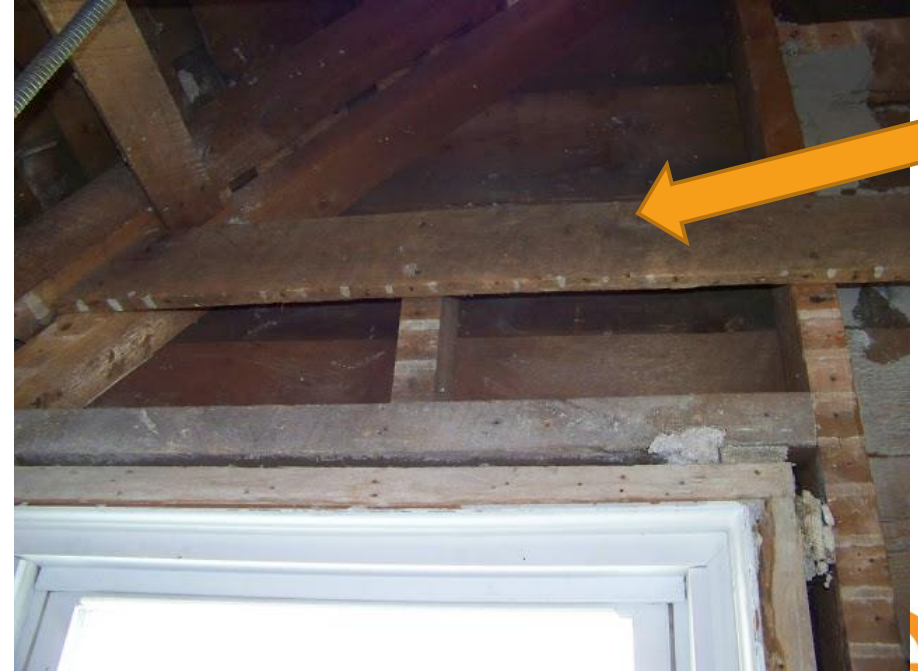
**Weatherization insulation  
without air barriers.**

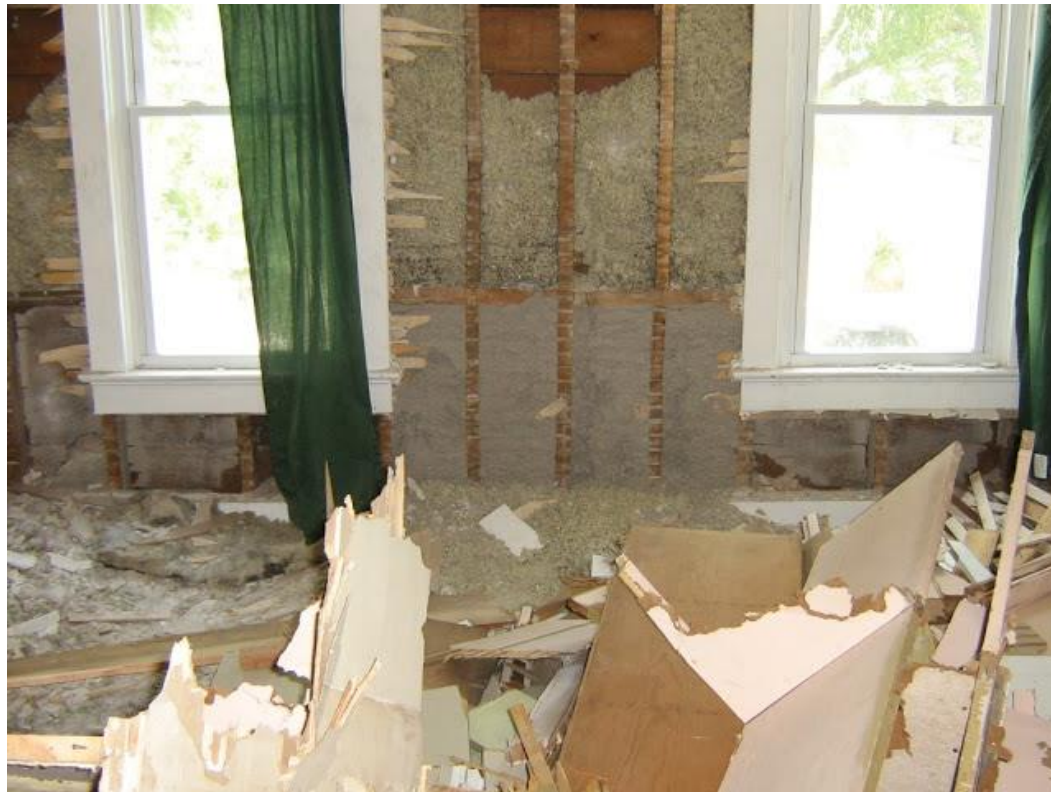
**Mixed weatherization insulations and missed cavities**

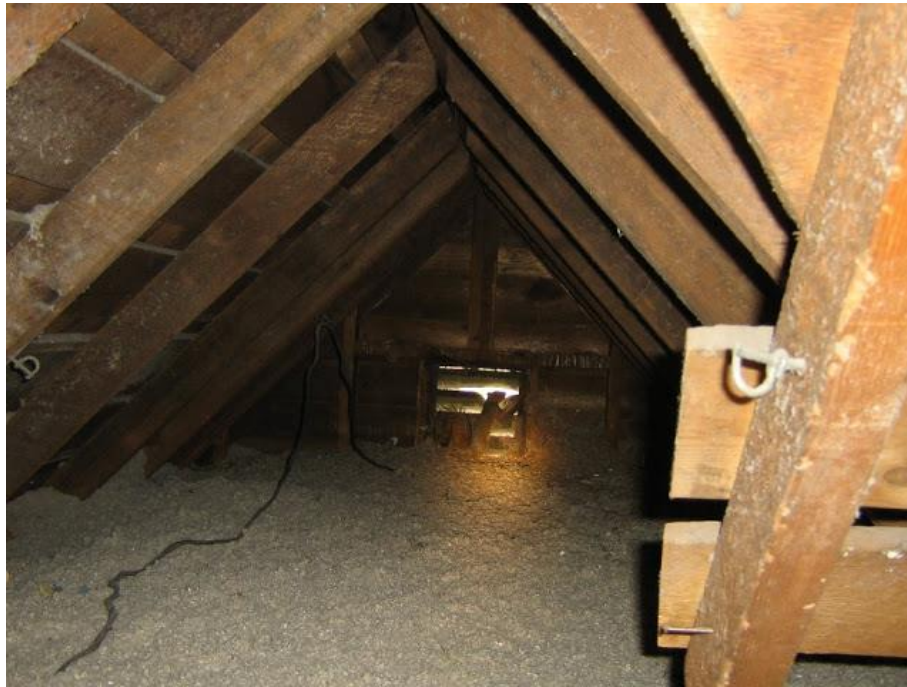
**Top floor attic with squirrel's nest stuffed into venting**

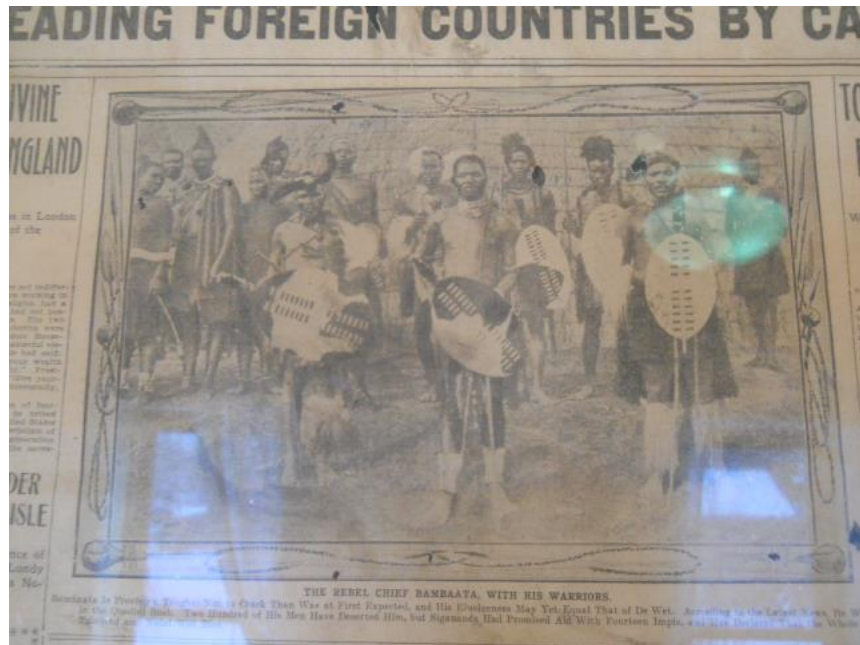
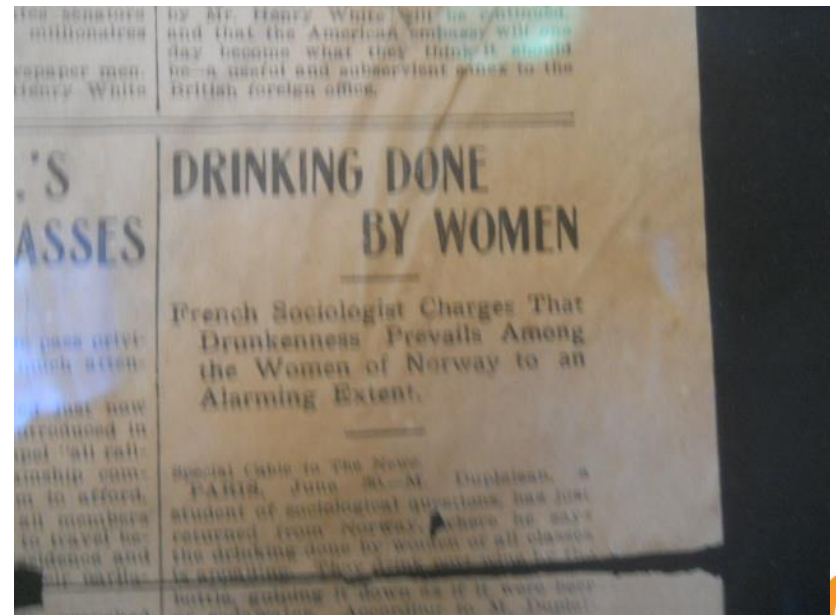
Newspaper found under siding on exterior of framed 2<sup>nd</sup> floor

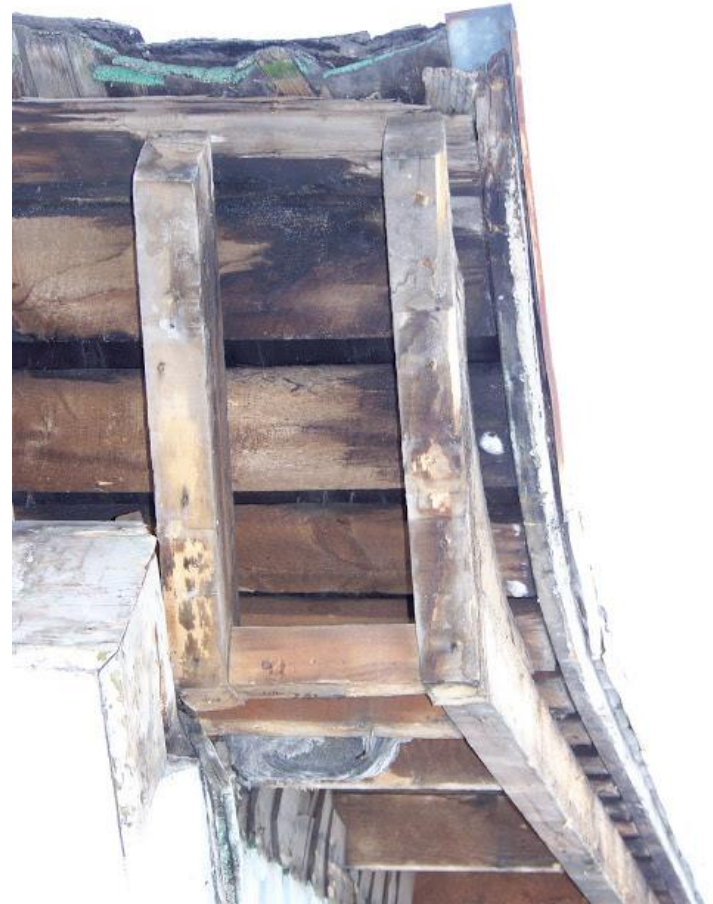
**6 layers of shingles,  
3 cedar shake, and  
3 asphalt and some  
nice moss growth  
on north side**

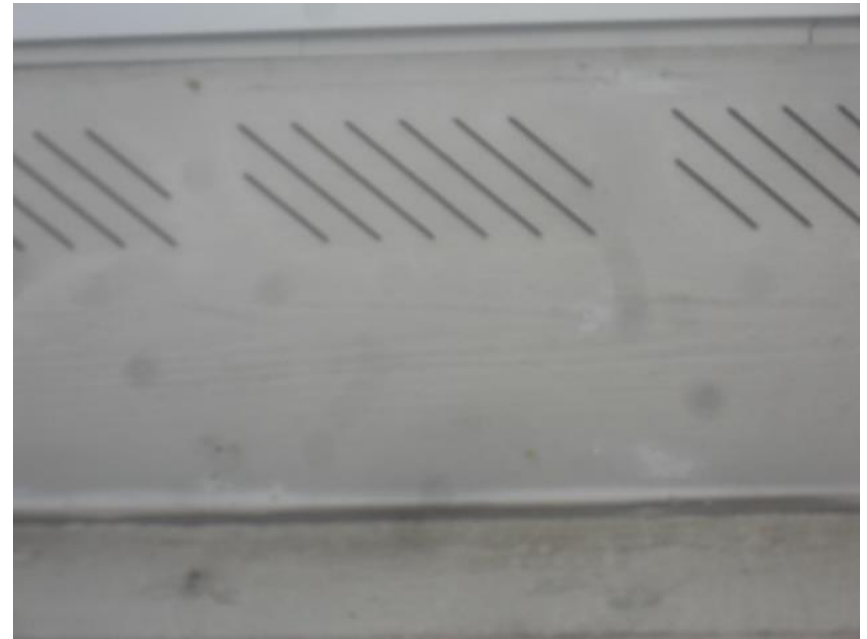
**Discontinued continuous  
cement board soffit**
