Temperature Monitoring & Analysis

New Metrics of Weatherization Success?

2014 RESNET Building Performance Conference

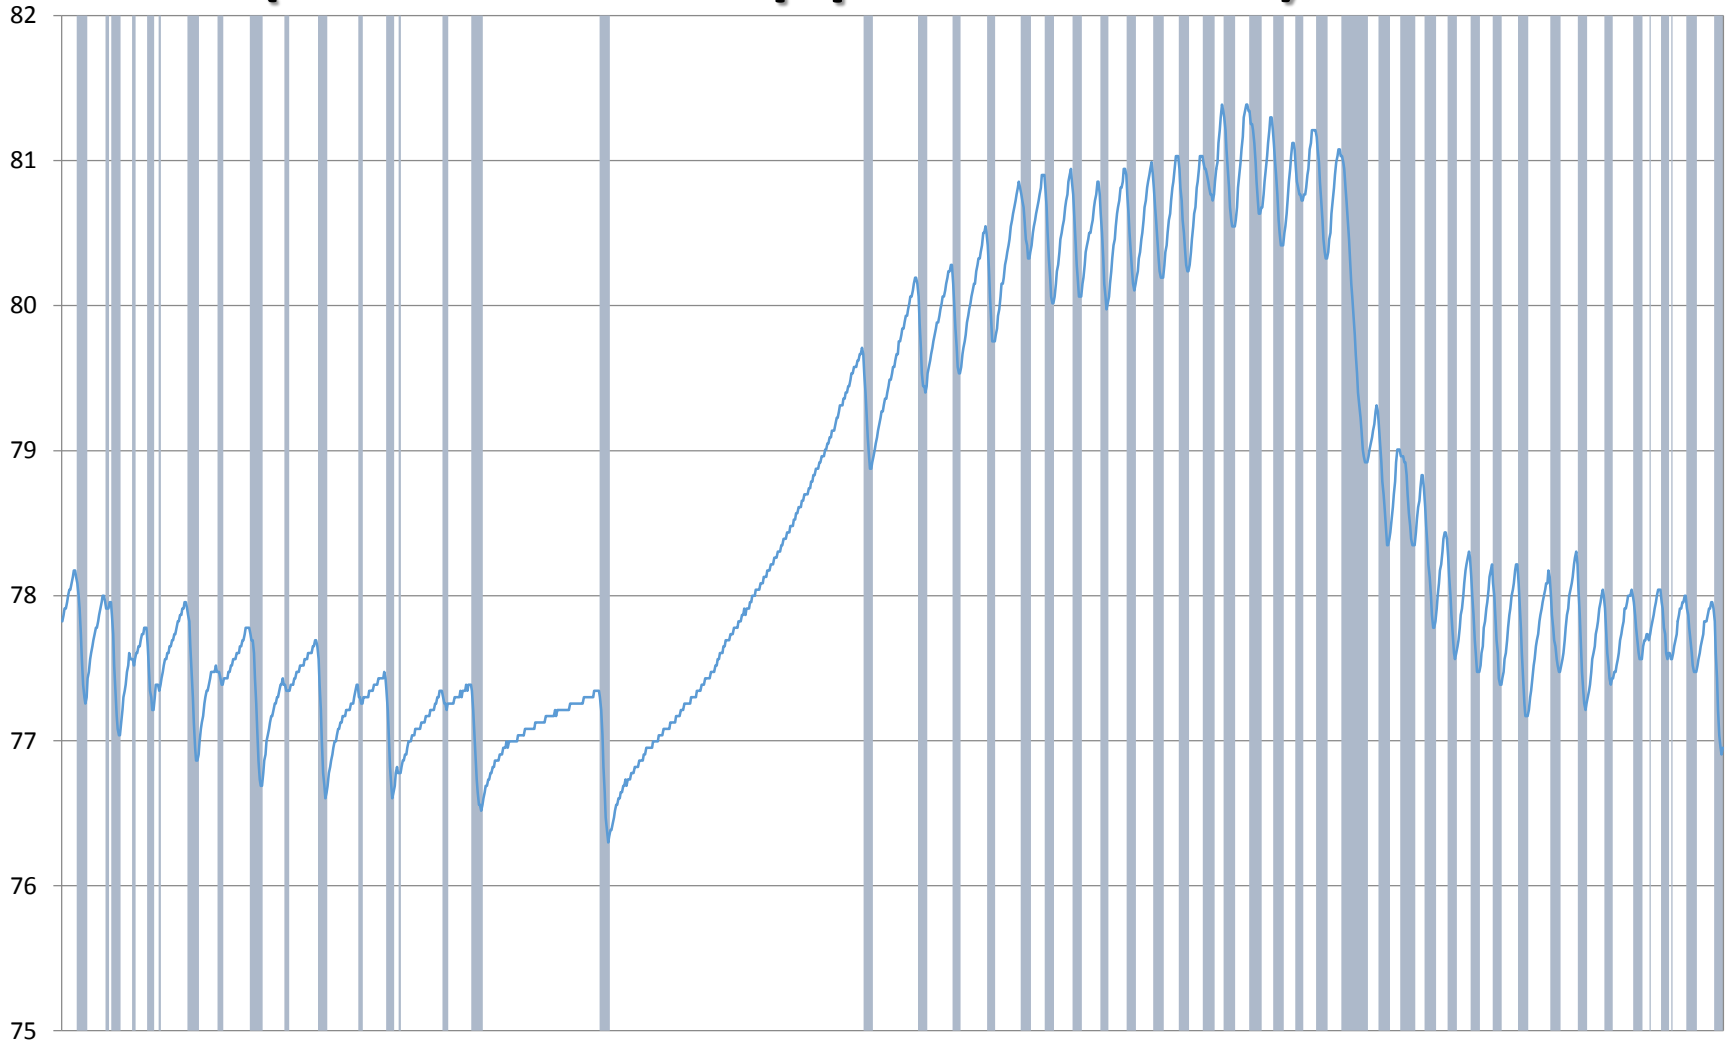
This AC Unit is Clearly Oversized

(outdoor air temp peaked at 95 F)

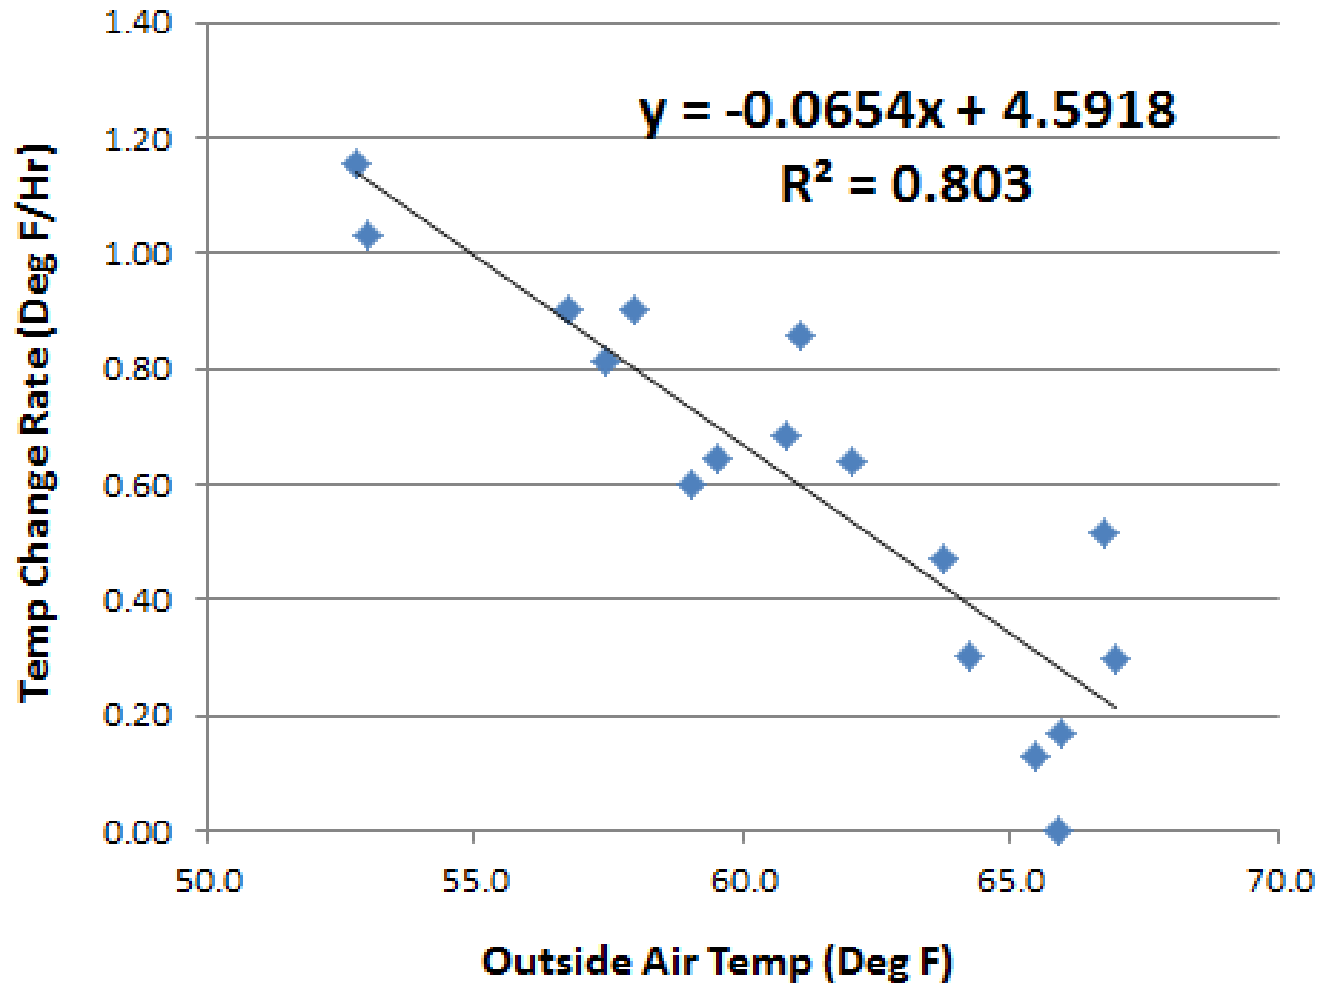
Measuring Temperature Change (12 am – 6 am ... Low Internal Gains)

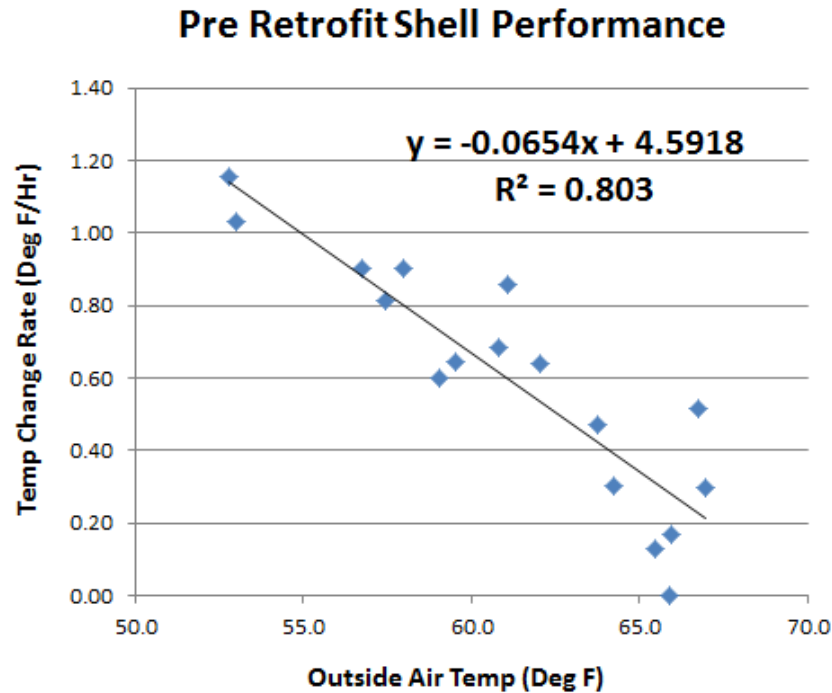
Convert to Performance Standard

1.98 Deg/Hr at 40 F Outside
6.6% of the Temp Diff/Hour

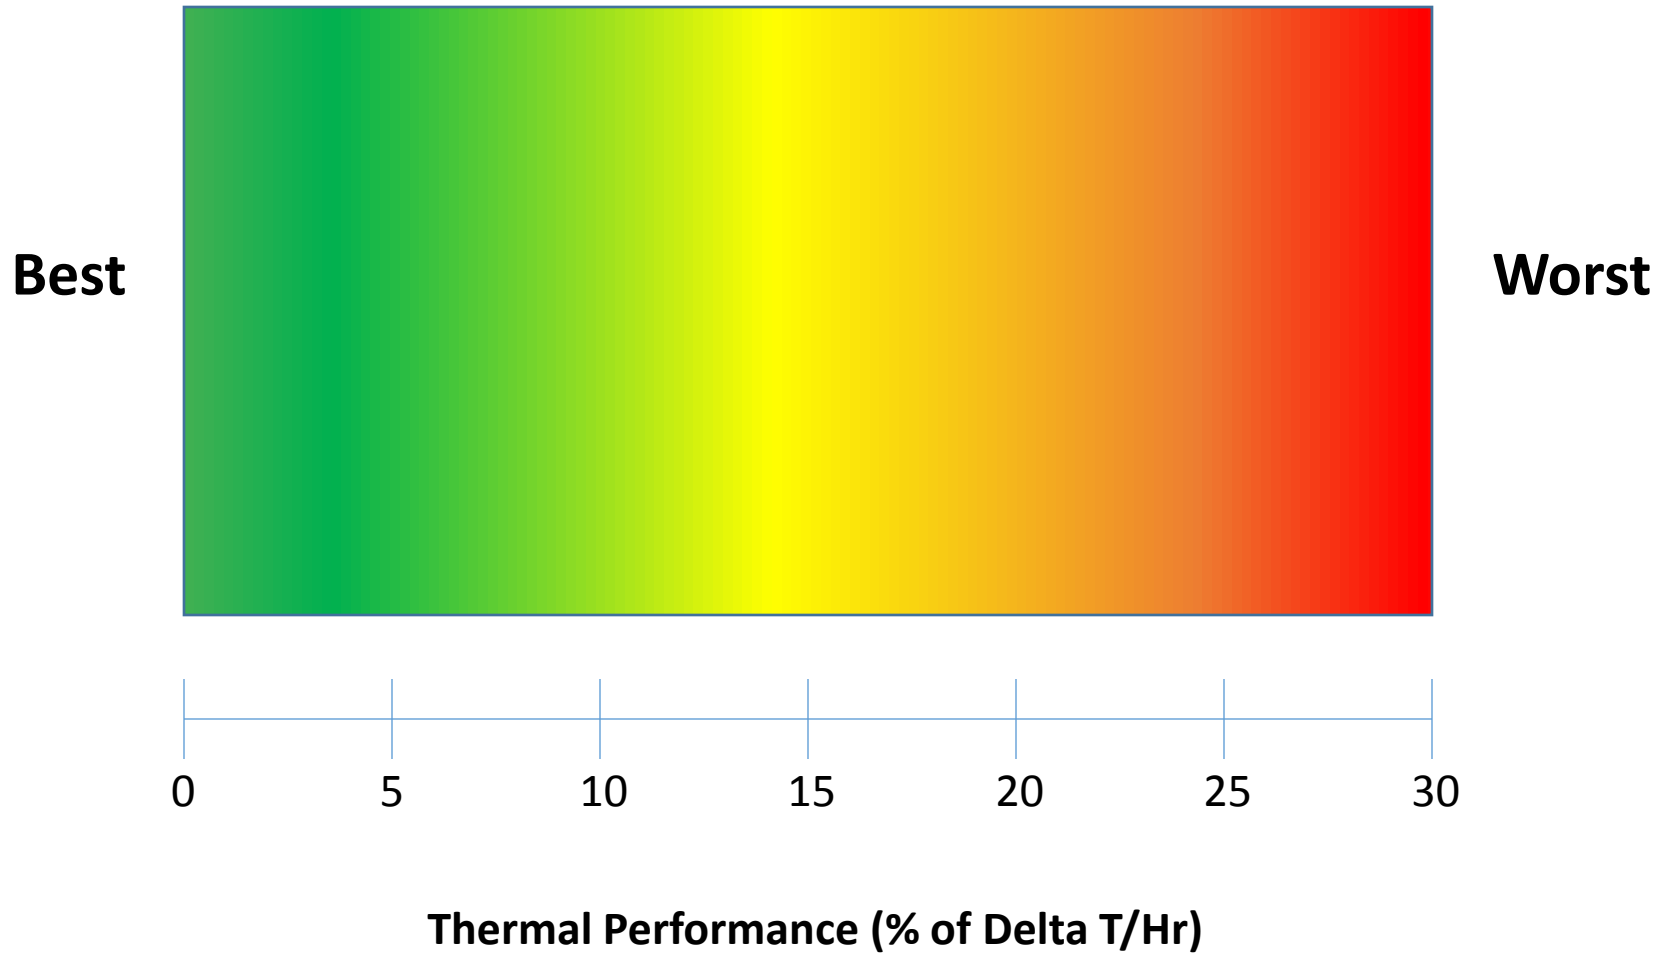
Compare Thermal Performance

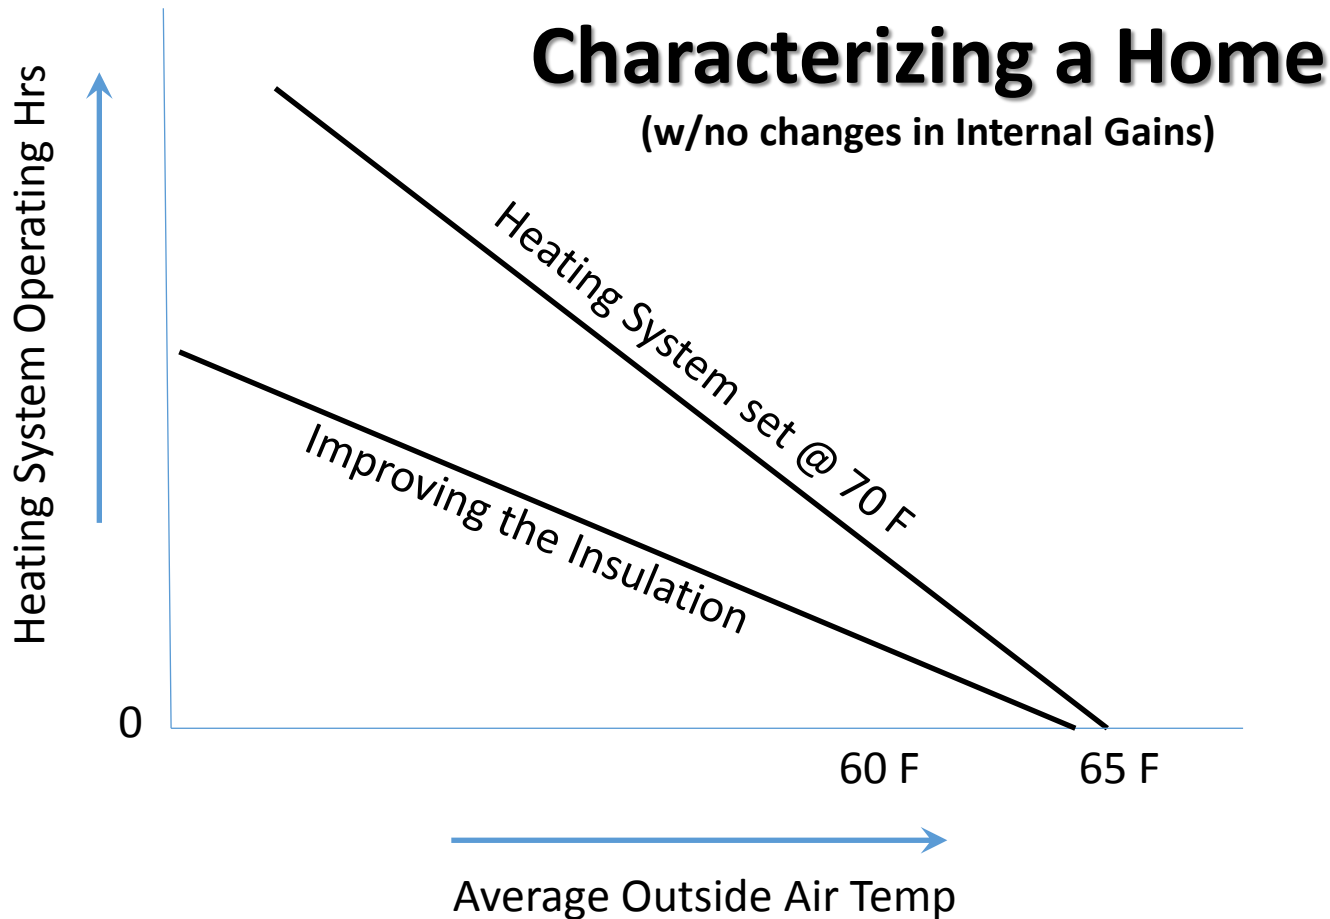
Compare run times from midnight to 6 AM

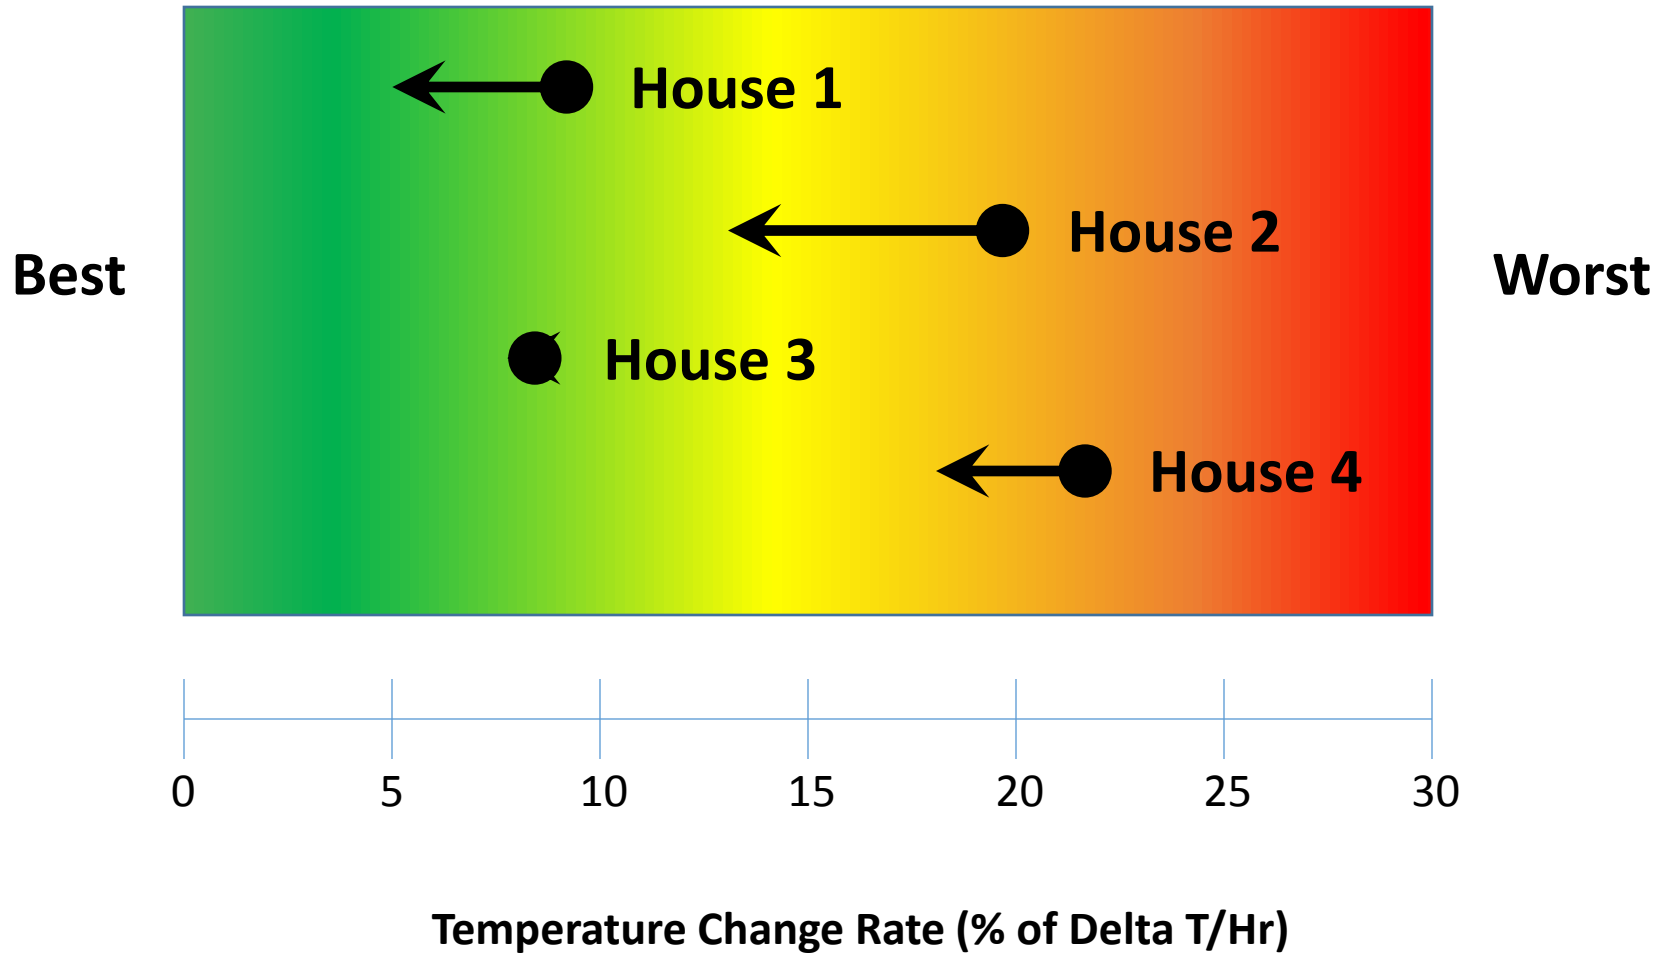
Thermal Performance Standards
