# The Evolution of a Crawlspace – Lessons Learned From a Big Energy Retrofit

Mike Barcik, Southface & Skye Dunning, BPS

*RESNET 2014 Conference*

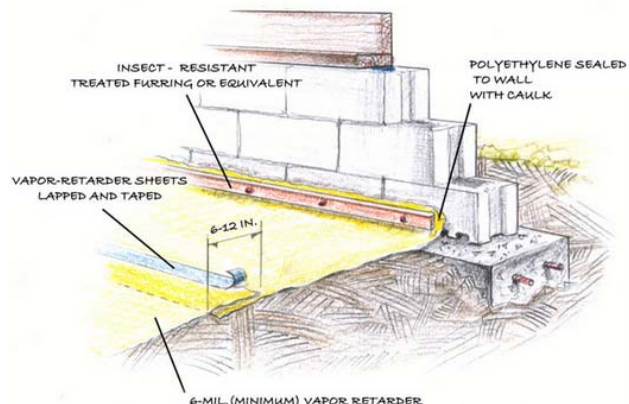
CRAWL SPACE - VAPOR RETARDER OVER SOIL

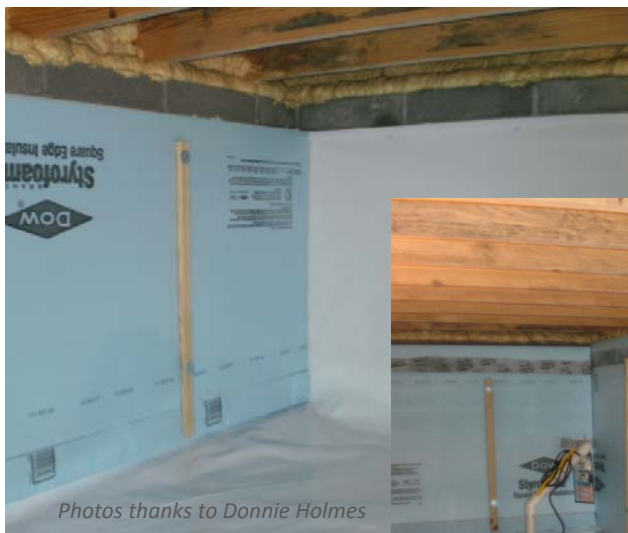
Gap for pest inspection

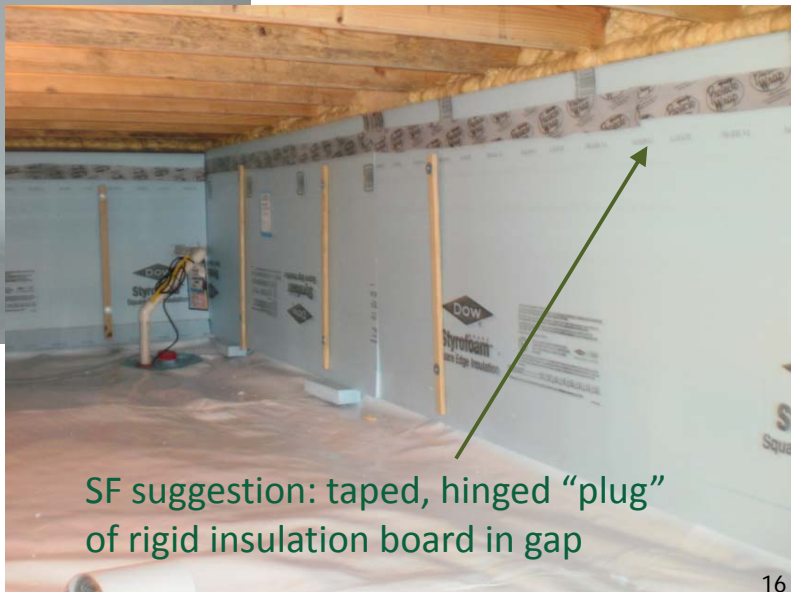
SF suggestion: taped, hinged "plug" of rigid insulation board in gap

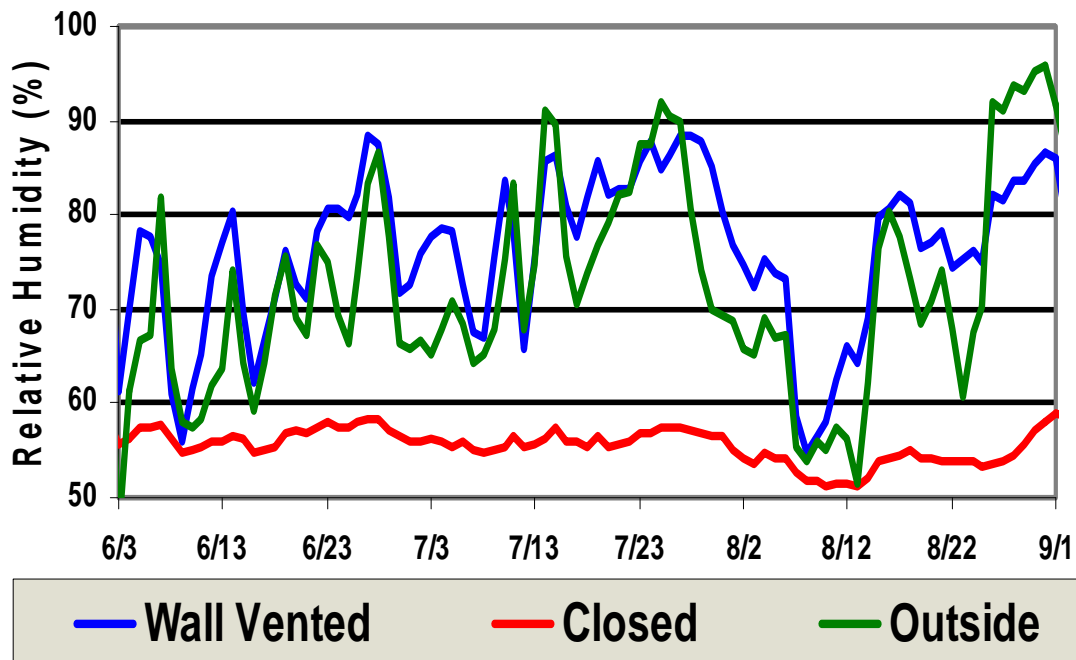
## Crawl Space Moisture Levels Summer 2002

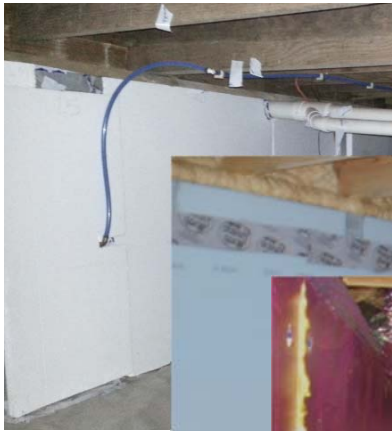
EPS foam  
with borate

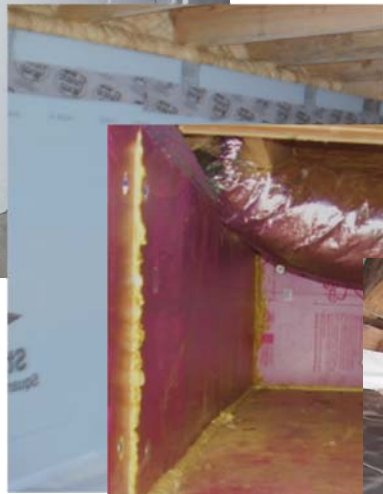
XPS foam

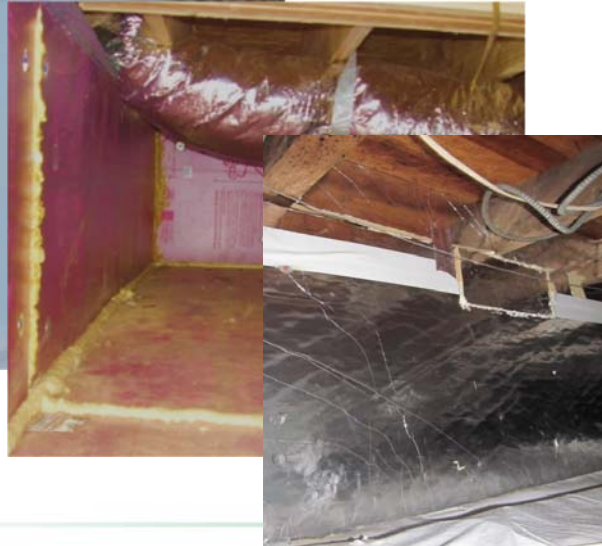
Poly-iso foam

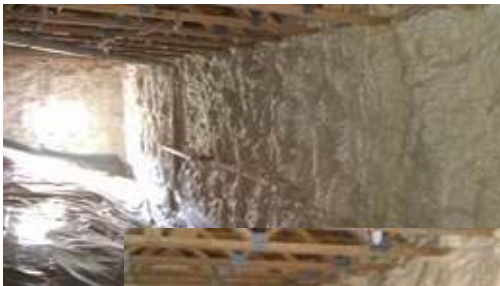
Open cell

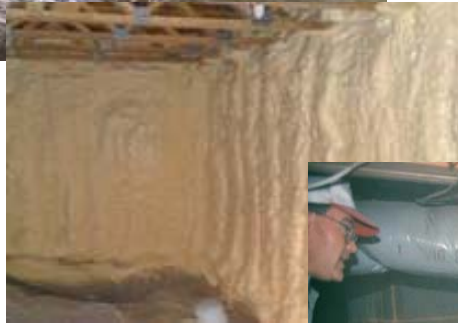
Closed cell

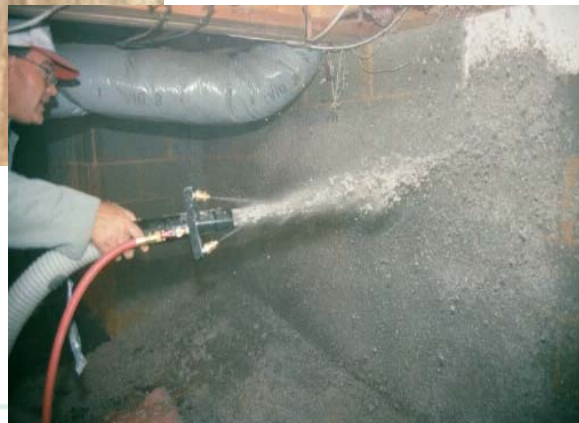
High-  
borate  
cellulose

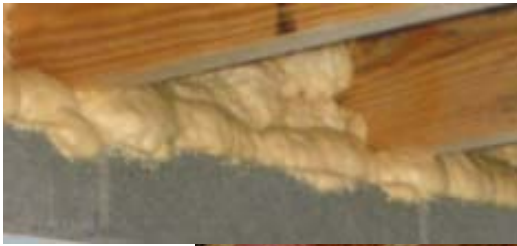
Closed cell foam

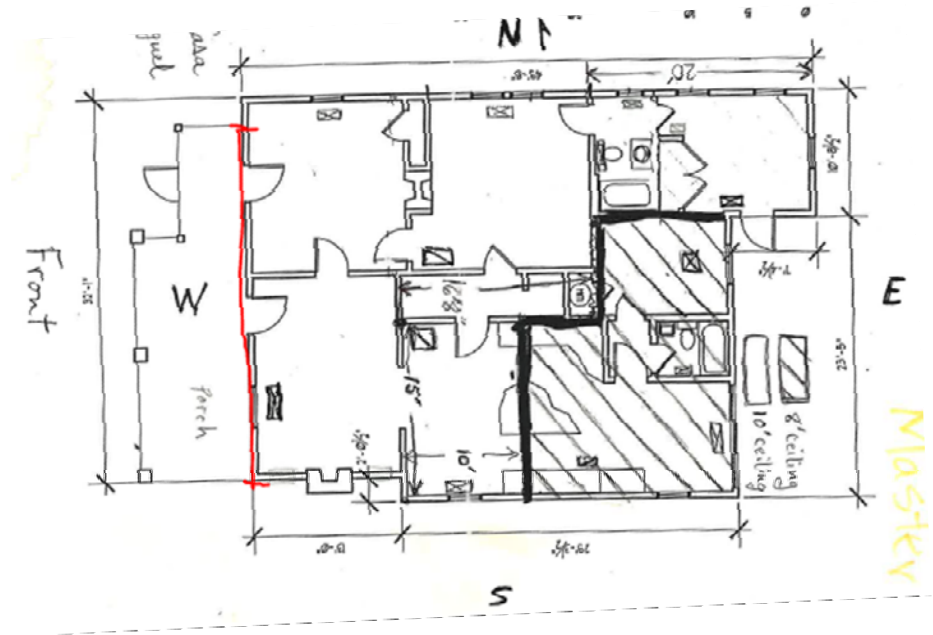
Above: Red line shows location of wall separating house foundation from porch foundation

Rim joists were sealed and insulated with batts and foam board. I also found more holes in the floor that were now easily observed (they had formerly been covered by batts). These were fairly simple to seal using a foam gun. Because my house features a 30' front porch, it was necessary to frame, sheath, and insulate a separation wall to isolate the vented porch crawlspace from the unvented main portion under the house.

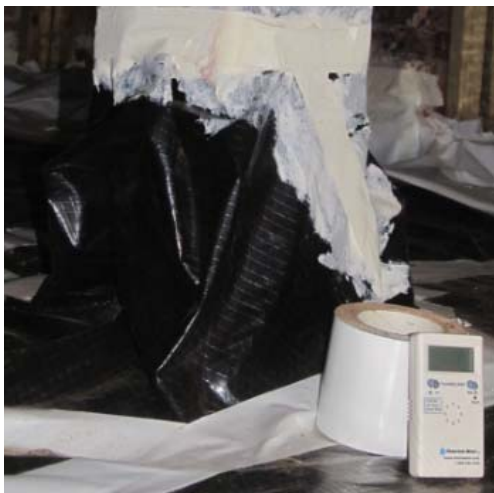
*Sensor with alarm tracks if RH gets above 65%*

I also have a separate Relative Humidity (RH) sensor with an alarm that will alert me if the moisture levels get too high. So far, only seven hours in the first 200 days have exceeded the 65% RH alarm threshold that I programmed and I believe will prevent mold growth from occurring. Typically the crawlspace RH is ~55% which is where I have set the humidistat on the dehumidifier.

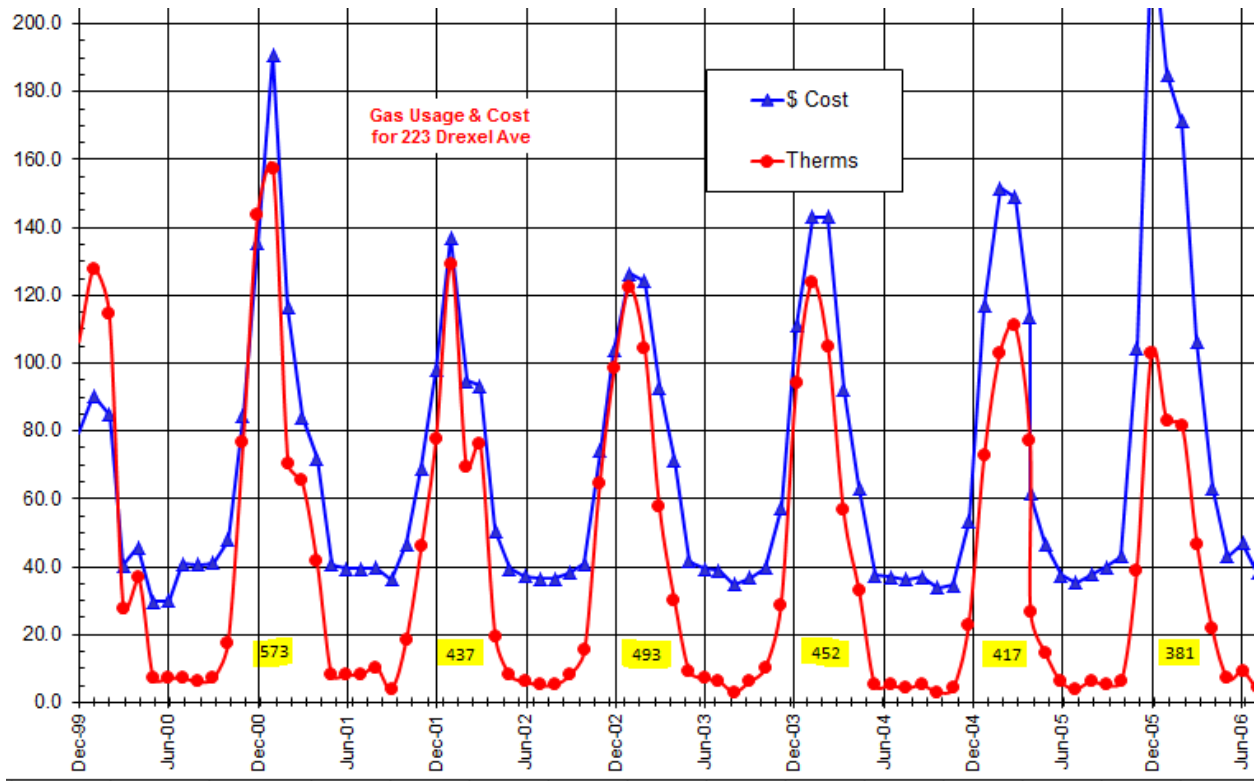
Above: Gas usage for first seven winters of occupancy (**highlight** values are seven coldest months)

Although it was a pretty mild winter compared to the previous two, on the few cold days we had, I noticed our furnace operation seemed to be significantly less (and our gas heating therms dropped ~35% from 299 in winter 2010-11 to 196 in winter 2011-12 and 202 therms for winter 2012-13). I would expect that usage will go up some as winter 2013-14 appears to be significantly colder.

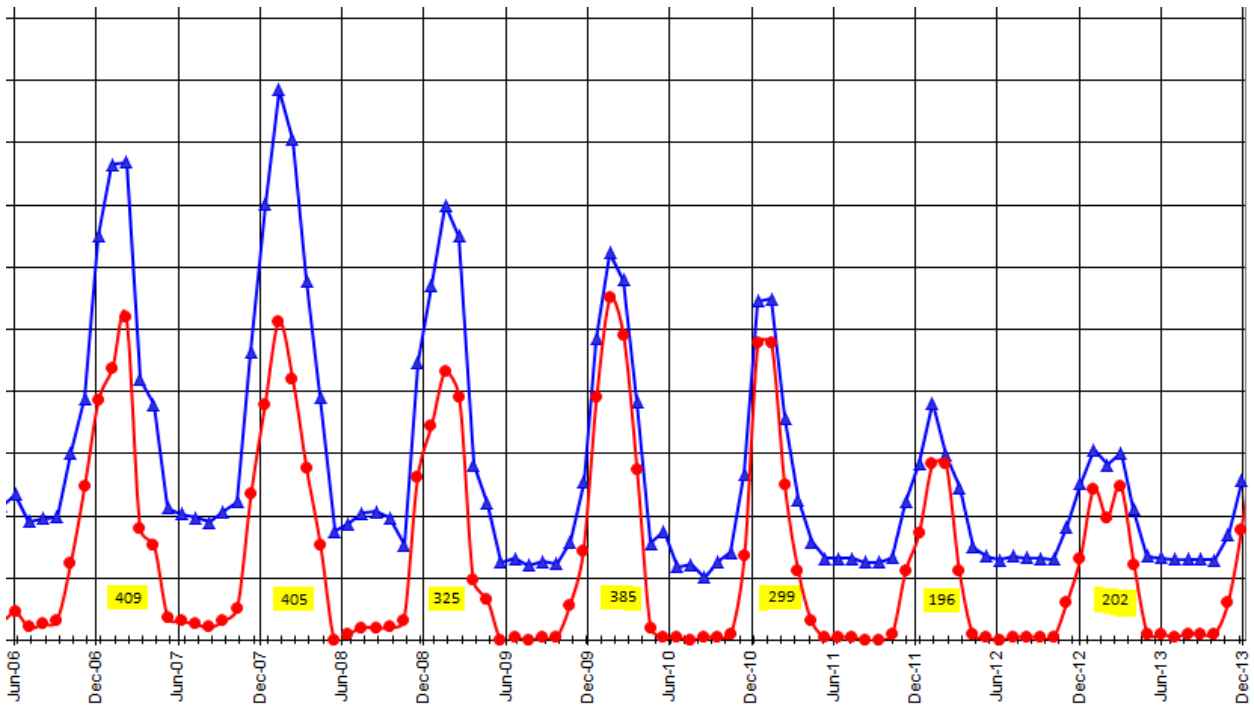
Below: Gas usage for latest seven winters of occupancy (**highlight** values are seven coldest months)
